Geotechnical Analysis: Quarry Spitz, Austria

Project Key-Facts:

RIEGL instrument	LMS Z-420i
Object of interest	Quarry Spitz, situated along the Danube, Austria
Results	Mass-balance of landslide, Geotechnical Analysis of the quarry

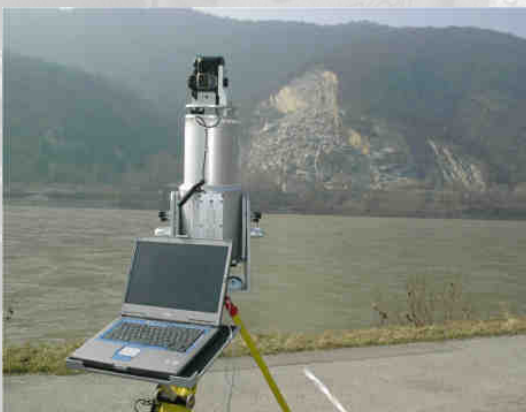
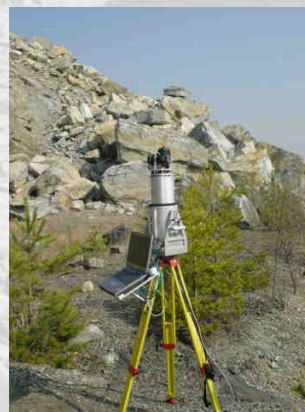
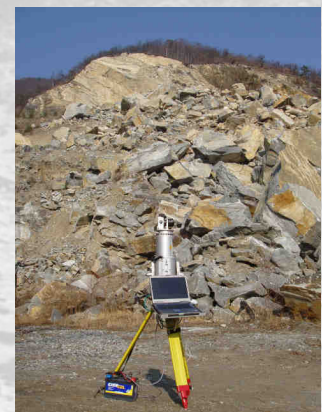
Scanner at work:

Number of scan-positions	5
Time needed for data-acquisition	4 hours
Time needed for post processing	3 hours
Acquisition workflow	panorama scan (VxH 80°x360°), registration of scan-data via control-points, measured by Differential GPS
Acquisition platform	Standard Surveying Tripod

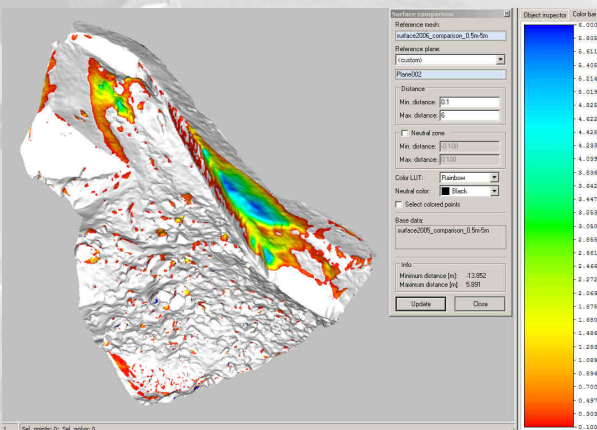
The screen-shot on the left shows the comparison between the two measurement-campaigns, realized using RiSCANPRO. Visualized is the model of 2005, showing the big rock-block of the landslide, which was coming down during the winter-season. The color-bar ranges from 0.1m (red) to 6m (blue). On top of the model a second smaller landslides is visible, which is in constant movement, because of a wet-zone in this area, causing permanent instability. The bottom-zone of the model, shows some point by point movements, resulting from some movements of single rock-blocks.

To compare the two different situations (before and after the landslide) only the relevant area was scanned in 2006 again.
